Case Studies on Paper Machine Vibration Problems

Andrew K. Costain, B.Sc.Eng.

Bretech Engineering Ltd., 70 Crown Street, Saint John, NB Canada E2L 3V6
email: andrew.costain@bretech.com website: www.bretech.com

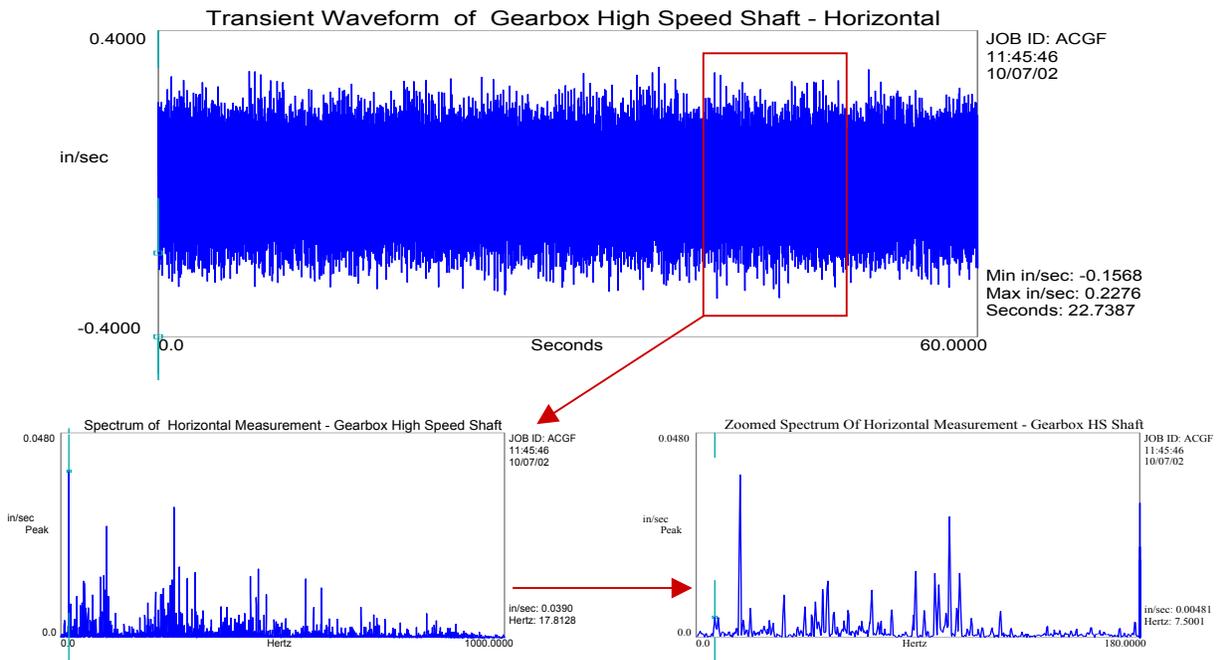
Figure 3 • time waveform, fft, and zoom fft of 60 second transient vibration measurement

Visual observations, with the aid of a strobe, indicated that under certain conditions, the drive appeared to be oscillating or “hunting”. Transient vibration measurements, as shown in Fig 3, below, did not exhibit any corresponding modulation of vibration amplitude.

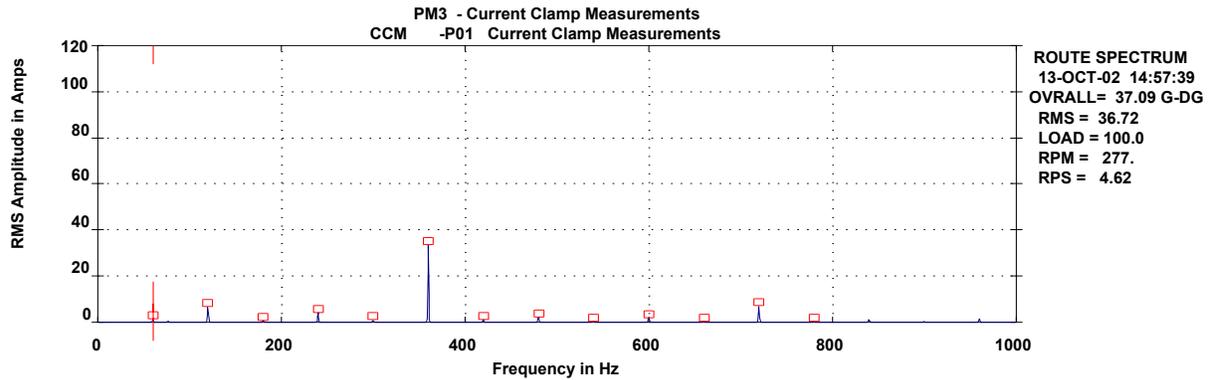
Figure 4 • fft of motor current

Motor current measurements, as shown in Fig 4, below, exposed a high 6X line frequency peak, indicating a possible dc drive rectifier fault.

Although vibration amplitudes were found to be very low, recommendations were submitted to replace the SCRs and install a “notch” filter to prevent continuous operation of the drive in the range of 6 to 8 Hz. Since implementing the recommendations, no additional failures have occurred.

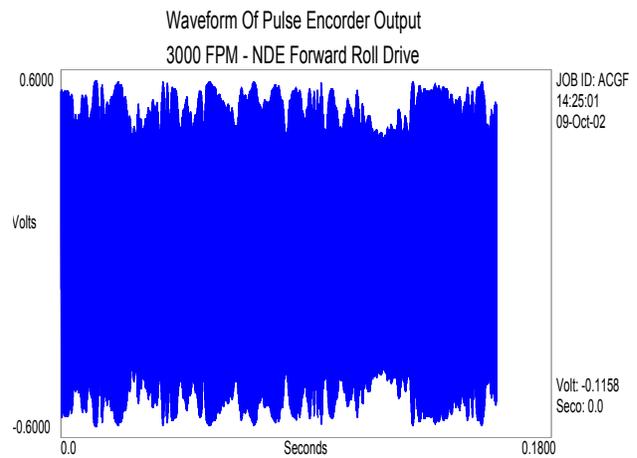
Figure 5B • 180 mSec time waveform of encoder output

To further evaluate the observed drive oscillations, a shaft encoder was installed, providing a high resolution measurement (350 pulses per revolution) of shaft speed and any corresponding speed variations. The installed shaft encoder and output waveform are shown in Figs 5A and 5B, below. Some speed variations can be easily observed in the waveform.

Further analysis of the output waveform exposed frequency modulation at 6.5 Hz, and a 180° phase shift. Each of these are considered evidence of a torsional resonance – which is consistent with the failure mode. The bode plot (magnitude and phase vs frequency) is shown in Fig 6A, below. To further investigate the possibility of a resonance problem, forced response testing was conducted. The results for the jackshaft, shown in Fig 6B, below, indicate some response near the frequency of interest.

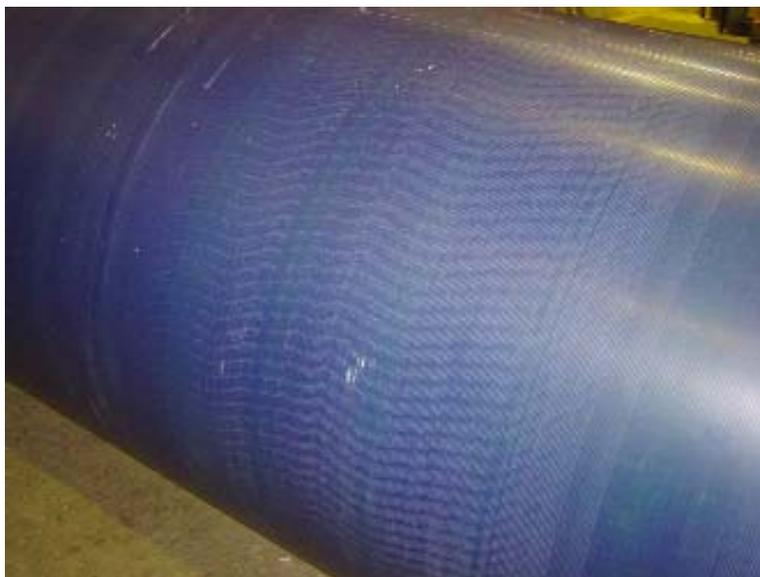
A 350 tpd uncoated free sheet paper machine recently changed to a seamed press felt to facilitate faster, safer, fabric changes. This resulted in a significant increase in vibration amplitude at the 3RD press – detected by periodic monitoring. Other problems included significantly reduced roll cover life and runability issues. Fig 7, below, shows the v-nip roll “chevron” barring pattern.

Figure 7 • roll cover barring of 3RD press v-nip roll

It was determined that due to the 3RD press section geometry, the (top) granite roll induced a barring pattern in the press felt, which subsequently barred the resilient cover of the (bottom) v-nip roll. Recommendations to change the size of both the granite roll and the felt were implemented, resulting in a significant reduction of vibration amplitude, and improved machine runability.

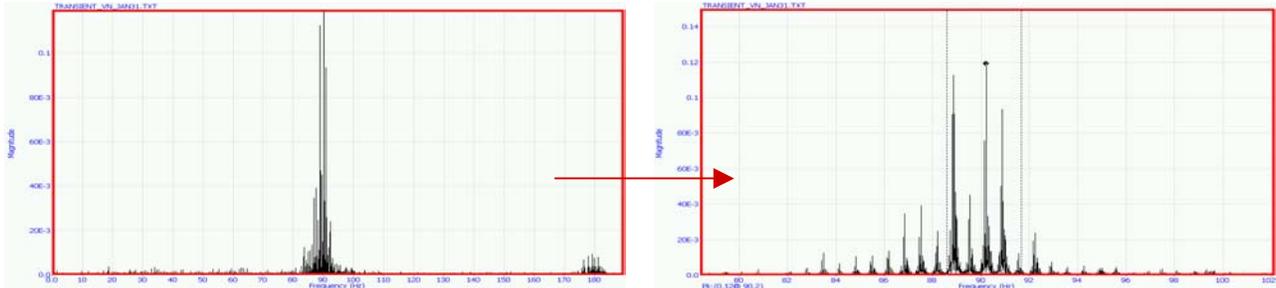
A baseline vibration assessment indicated a group of spectral peaks centered at 20 orders of turning speed for both 3RD press rolls (v-nip, bottom and granite, top). Figs 8A and 8B, below, show the fft and zoom fft for a v-nip roll measurement. Zoom analysis indicated a sideband spacing of 0.7 Hz, corresponding to the felt pass frequency of the new (seamed) felt.

Figure 8A • fft of v-nip roll

Figure 8B • zoom fft of v-nip roll

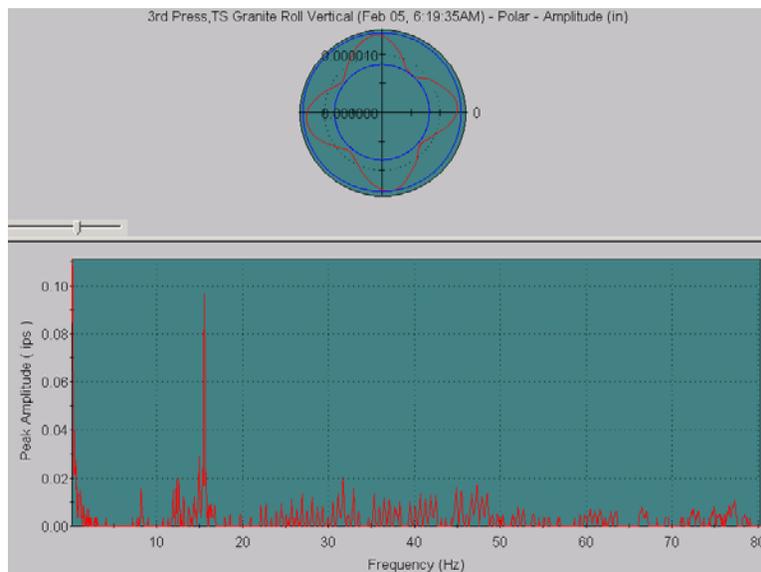
Figure 9 • speed trial polar plot time waveform and peak amplitude fft

A geometric analysis revealed that felt length (878”) is an integer multiple of the 34.93” Ø granite roll circumference. A polar plot of speed trial time data indicated a 4X node at the granite roll, as shown in Fig 9, below.

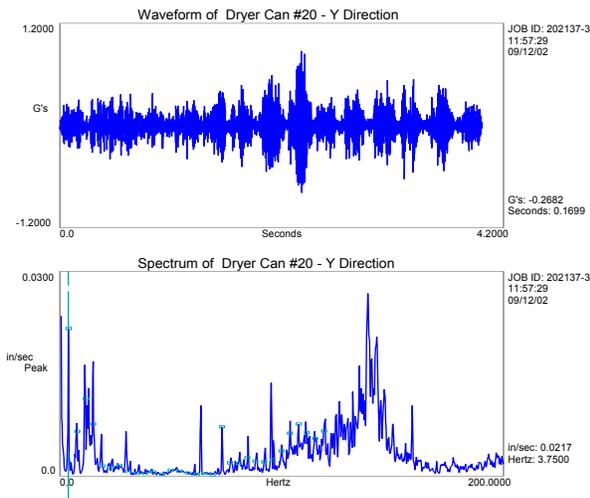
A baseline vibration assessment revealed; 1) several dryer cylinder bearing defects, and 2) felt roll unbalance problems, as shown in Figs 10A and 10B, below.

Figure 10A • dryer bearing defect

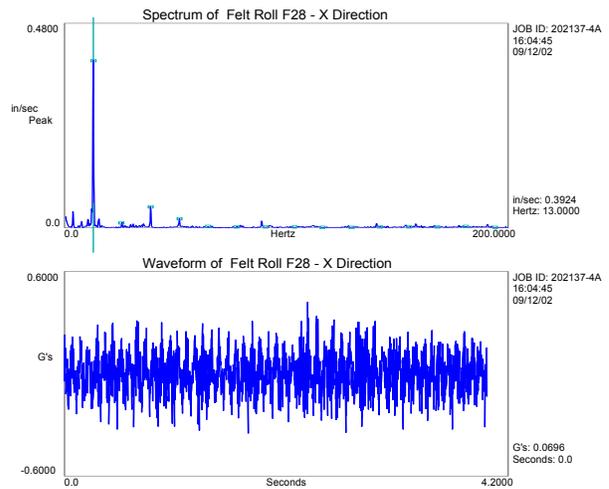
Figure 10B • felt roll unbalance

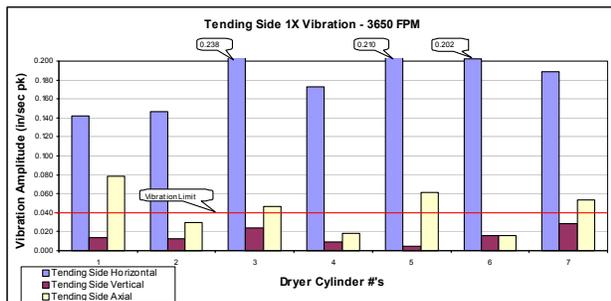
Figure 11A • 1X dryer vibration amplitude

As shown in Figs 11A and 11B, below, excessive dryer cylinder unbalance was detected at dryer section #1. Similar results were found at section #2 and #3, with 1X dryer (4 Hz) amplitude up to 0.3 in/sec pk in the machine direction (target value is 0.04 in/sec pk).

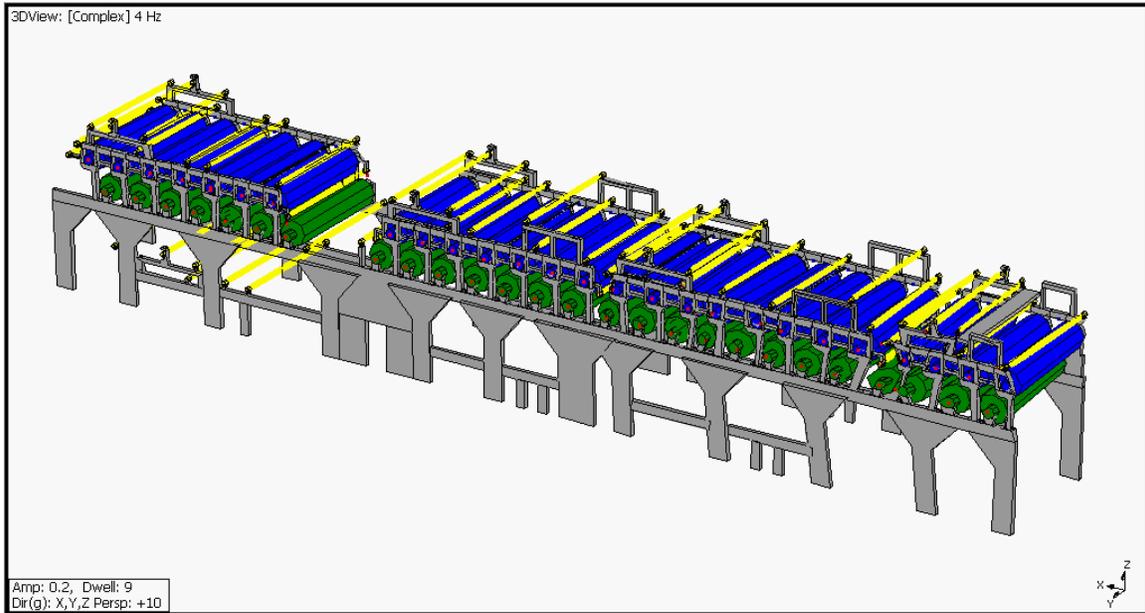
Figure 12 • operating deflection shape model

An operating deflection analysis indicated excessive machine direction motion in the supporting structure. The ods model is shown in Fig 12, below. Machine direction is +x.

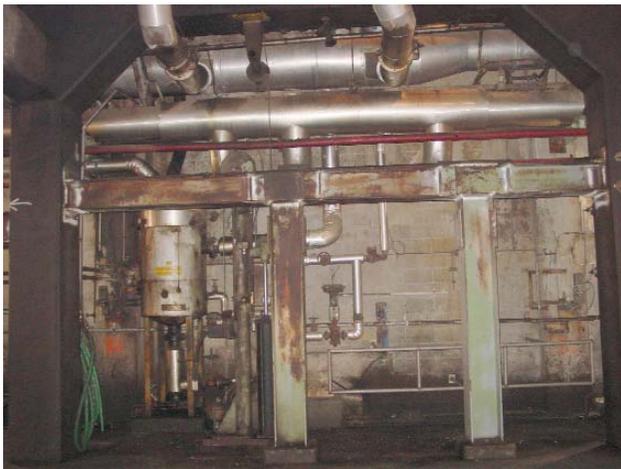
Visual examination of the support structure revealed previously installed machine direction braces, as shown in Fig 13A, below. These were found to be undersized, and in generally poor condition, with many of the structural welds broken.

Figure 13A • failed structural brace

Recommendations were submitted to design and install suitable machine direction bracing, similar to that shown in Fig 13B, above. At the time of writing, this work is in progress.

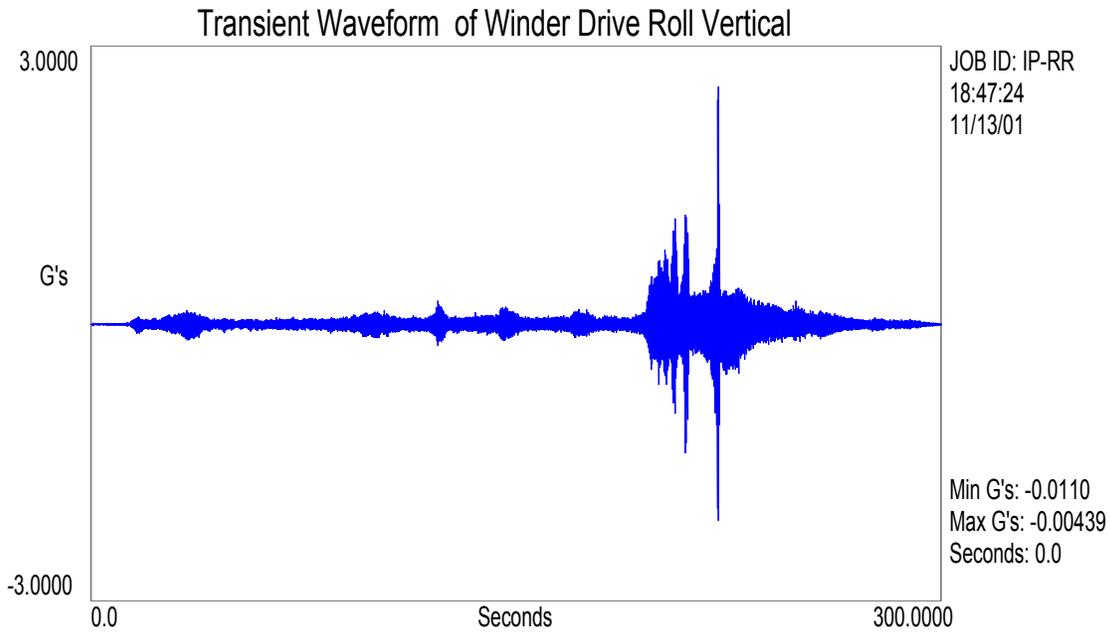
Figure 14 • time waveform of 1 winder cycle

A 300 sec time waveform (1 winder cycle) is shown in Fig 14, below.

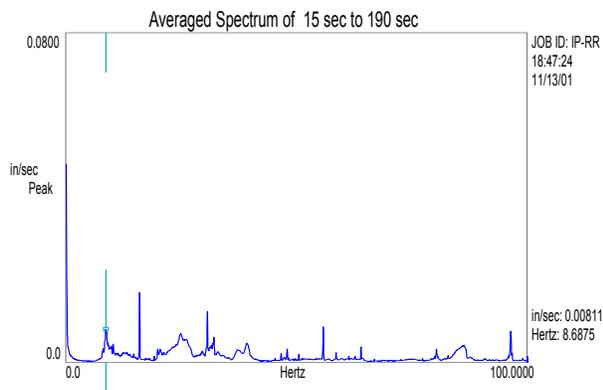
Figure 15A • fft of 15 to 190 sec

The averaged fft spectrum, as shown in Figs 15A and 15B, below, indicated a significant broadband response in the range of 34.5 Hz through 39.5 Hz during the transient events.

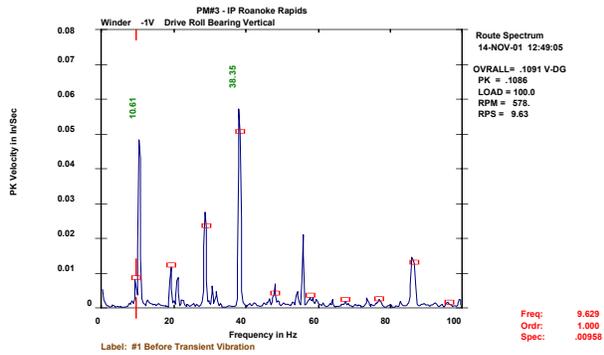
Figure 16A • fft before high transient vibration

Instantaneous spectra acquired before, during, and after the transient response include harmonic multiples of 1X paper roll turning speed, a good indicator of looseness. The high transient response is coincident with 4X paper roll turning speed. As shown in Figs 16A and 16B, below, the paper roll turning speed reduces during the winding process. During the high transient vibration 4X paper roll turning speed is 36.63 Hz.

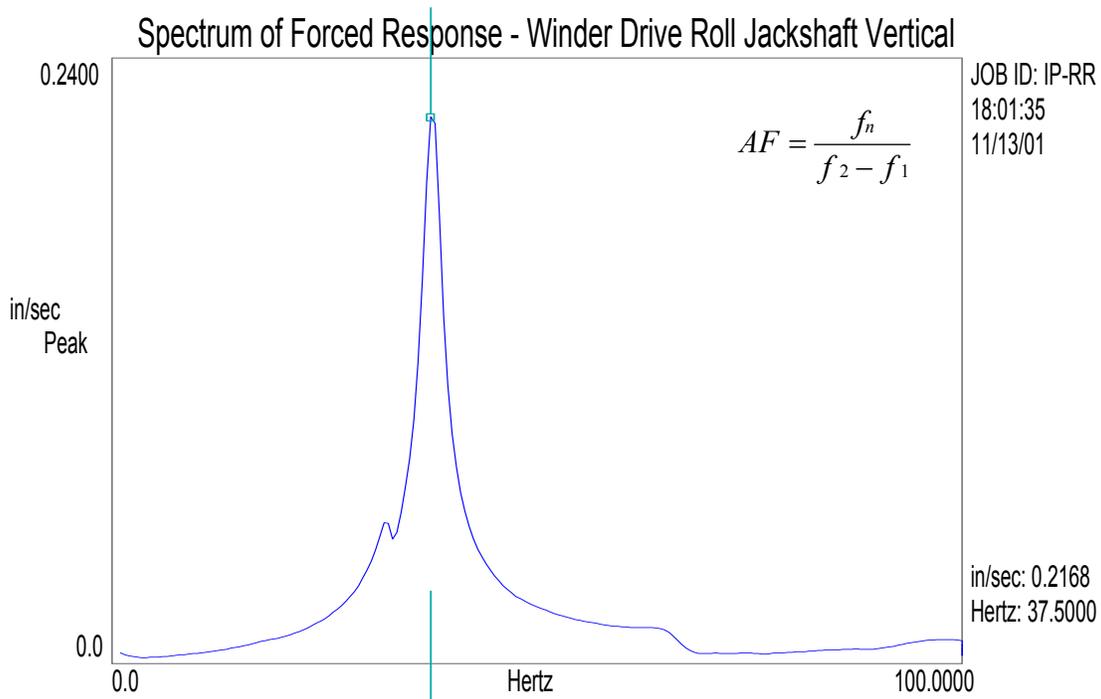
Figure 17 • vibration response of jackshaft

Forced response testing revealed a lightly damped system mode (natural frequency) of the drive roll jackshaft at 37.5 Hz. Resonance occurs when the 4X paper roll forcing function is coincident with the 37.5 Hz mode.

Since the winder operates at constantly changing speeds, isolation or a tuned absorber cannot solve this problem. Tuning (changing the natural frequency of the jackshaft) will work only if the mode is carefully adjusted to below the lowest value for 4X paper roll ($\cong 30$ Hz) but above the 3X forcing function. Changing the support design (bearings) to introduce system damping will reduce the amount of amplification.

Recommendations to minimize the forcing function (mechanical looseness) by correcting excessive bearing clearances and loose structural connections were followed, leading to a significant reduction in the transient vibration response.
