Case Studies on Paper Machine Vibration Problems

Andrew K. Costain, B.Sc.Eng.

Bretech Engineering Ltd., 70 Crown Street, Saint John, NB Canada E2L 3V6
email: andrew.costain@bretech.com website: www.bretech.com

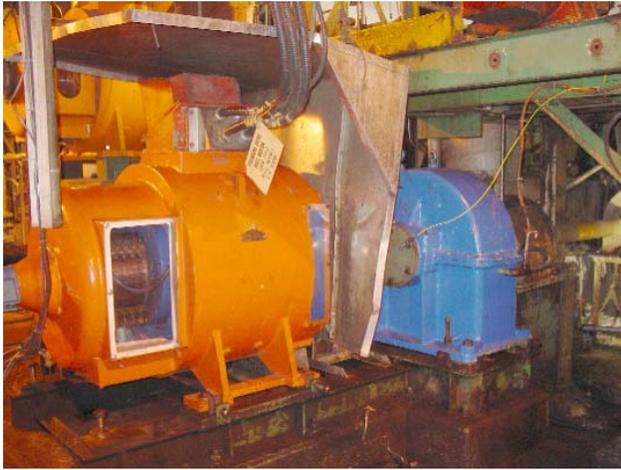
Figure 2A • drive and gearbox arrangement

A 550 tpd newsprint machine experienced several catastrophic failures at the forward drive roll gearbox. Specifically, the gearbox input shaft sheared in an apparent fatigue failure 3 times within a period of 6 months. The roll position is shown in Fig 1, below.

It was noted that an unexplained peak at 7.5 Hz was consistently observed in measurements throughout the drive train and at various machine direction measurements on the fourdrinier. This is well below the gearbox output speed of 17.8 Hz.

Further analysis of the output waveform exposed frequency modulation at 6.5 Hz, and a 180° phase shift. Each of these are considered evidence of a torsional resonance – which is consistent with the failure mode. The bode plot (magnitude and phase vs frequency) is shown in Fig 6A, below. To further investigate the possibility of a resonance problem, forced response testing was conducted. The results for the jackshaft, shown in Fig 6B, below, indicate some response near the frequency of interest.

Although vibration amplitudes were found to be very low, recommendations were submitted to replace the SCRs and install a “notch” filter to prevent continuous operation of the drive in the range of 6 to 8 Hz. Since implementing the recommendations, no additional failures have occurred.

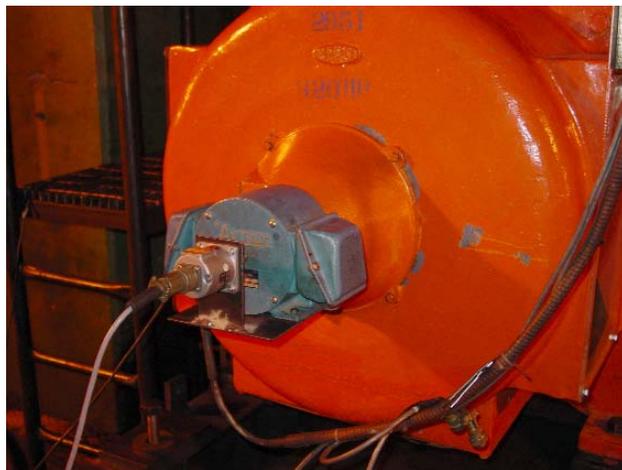
Figure 5A • installed pulse encoder

To further evaluate the observed drive oscillations, a shaft encoder was installed, providing a high resolution measurement (350 pulses per revolution) of shaft speed and any corresponding speed variations. The installed shaft encoder and output waveform are shown in Figs 5A and 5B, below. Some speed variations can be easily observed in the waveform.

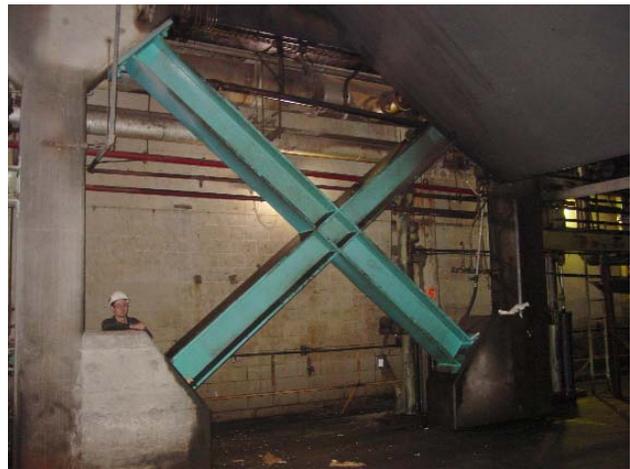
Figure 13B • example structural brace

Visual examination of the support structure revealed previously installed machine direction braces, as shown in Fig 13A, below. These were found to be undersized, and in generally poor condition, with many of the structural welds broken.

Recommendations were submitted to design and install suitable machine direction bracing, similar to that shown in Fig 13B, above. At the time of writing, this work is in progress.

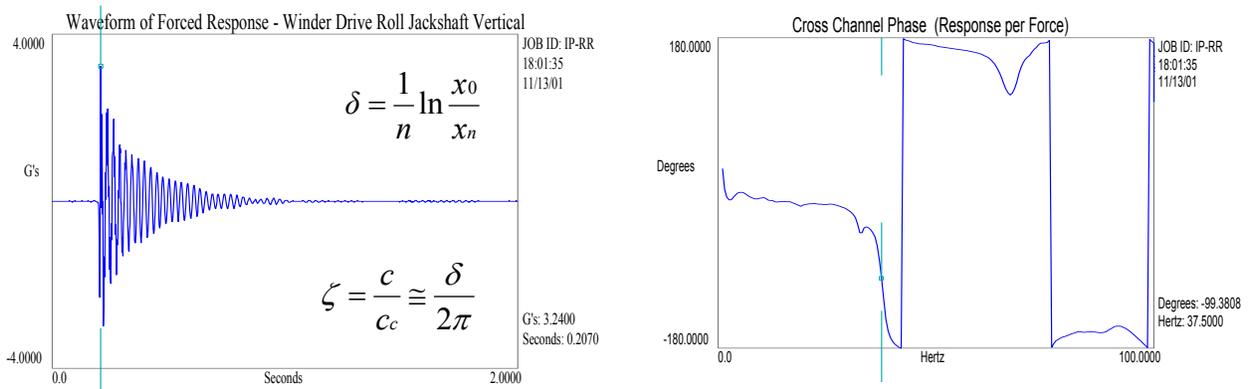
Figure 14 • time waveform of 1 winder cycle

Using the formulae shown in Fig 16A, below, the damping ratio is found to be at or near 0.025 (ie a lightly damped system).

Since the winder operates at constantly changing speeds, isolation or a tuned absorber cannot solve this problem. Tuning (changing the natural frequency of the jackshaft) will work only if the mode is carefully adjusted to below the lowest value for 4X paper roll ($\cong 30$ Hz) but above the 3X forcing function. Changing the support design (bearings) to introduce system damping will reduce the amount of amplification.
